LETTER REPORT
FOR
CLARK OIL
Hartford, Madison County, Illinois
TDD: T05-9403-007
PAN: EIL0833BAA

September 9, 1994

Re: Clark Oil
Hartford, Illinois
TDD: T05-9403-007
PAN: EIL0833BAA

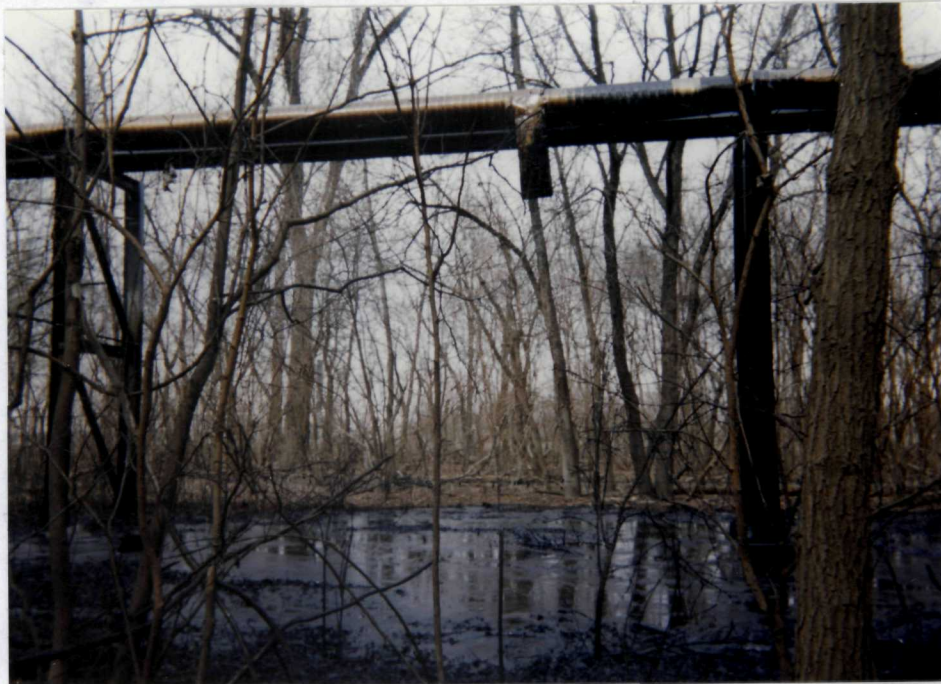
DESCRIPTION: Break in pipeline.

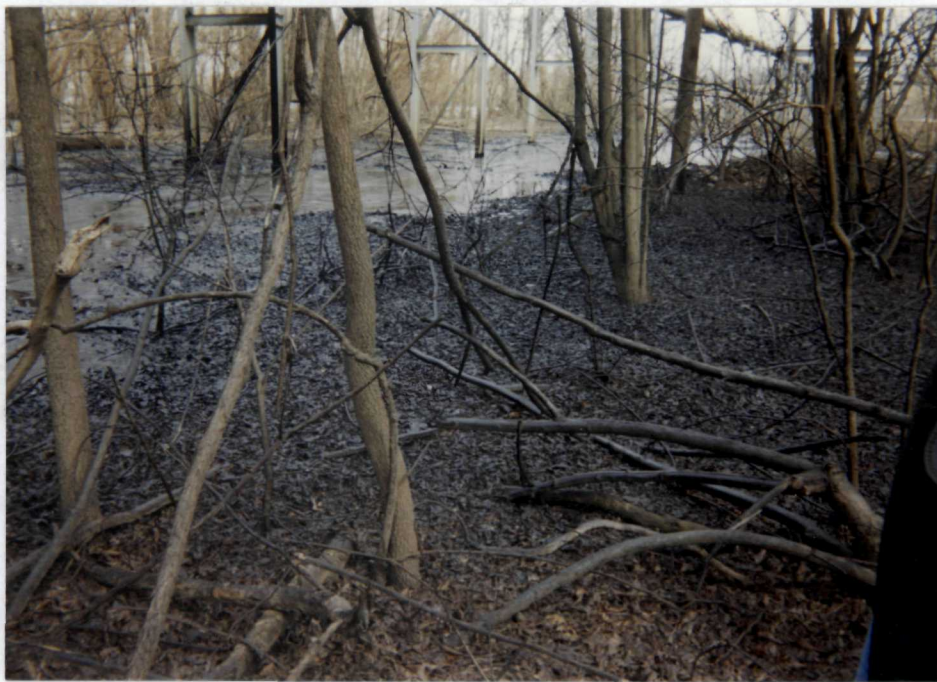
DESCRIPTION: Stained soil and leaves south of pipeline break.

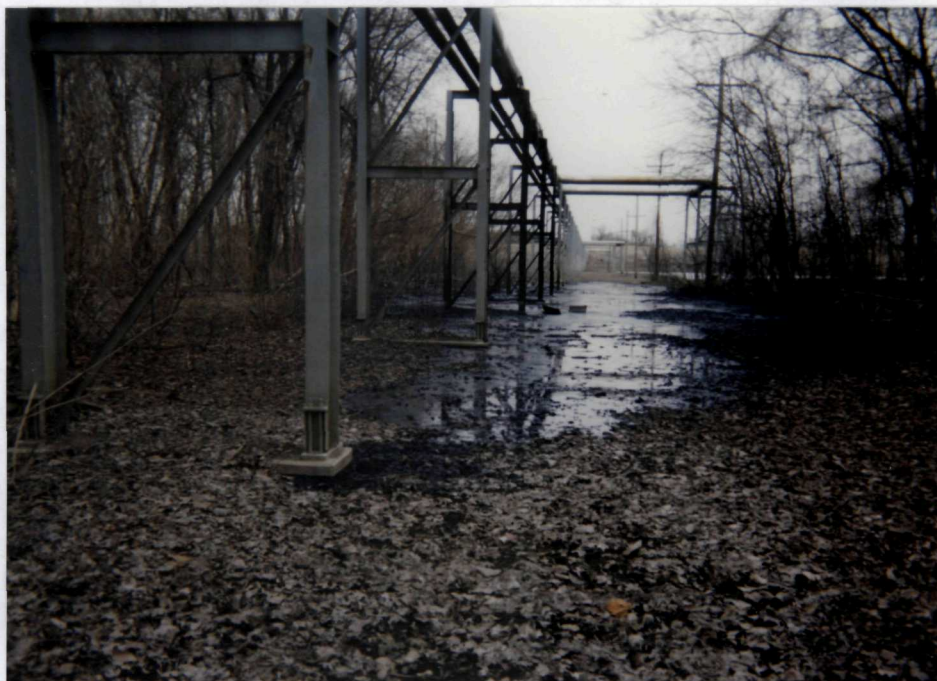
DESCRIPTION: Asphalt spill near pipeline. This is the point where spill ends to the west.

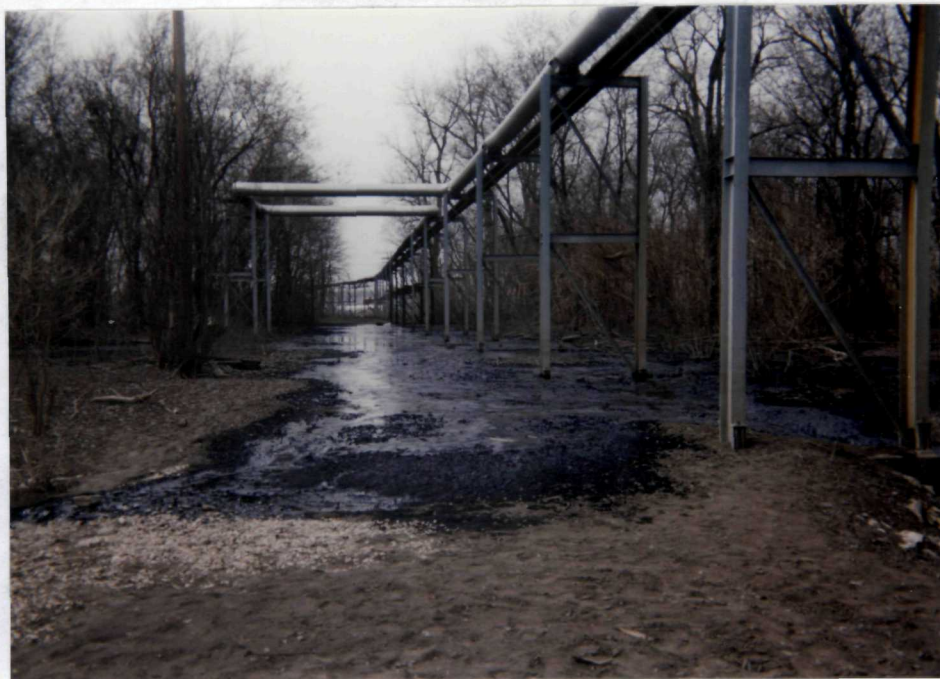
DESCRIPTION: Asphalt spill near pipeline looking west. Foreground is where asphalt spill turns and flows into drainage ditch.

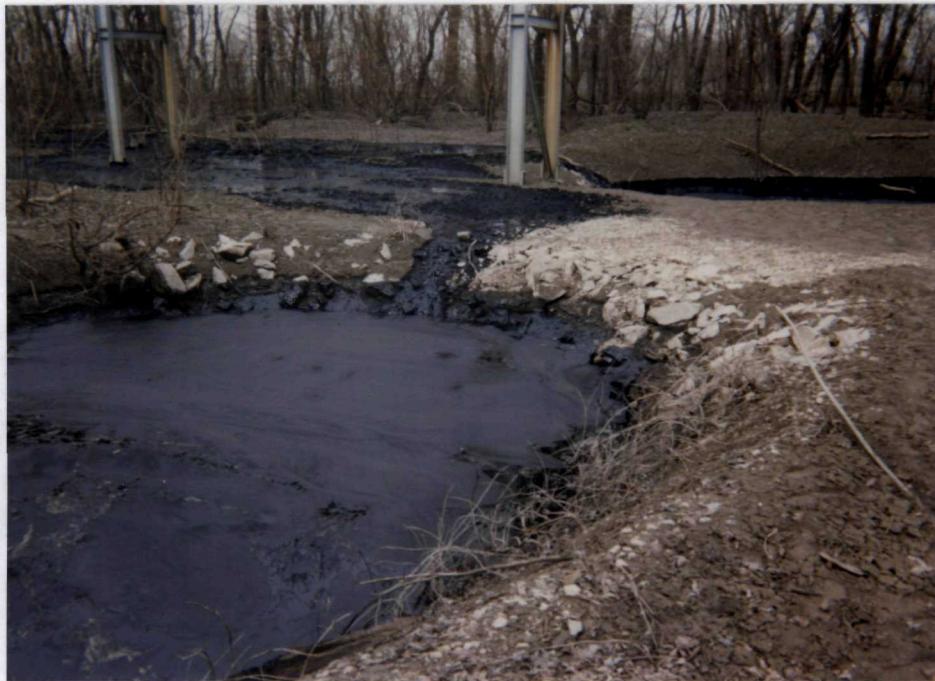
DESCRIPTION: Northern end of drainage ditch where asphalt first flows into ditch.

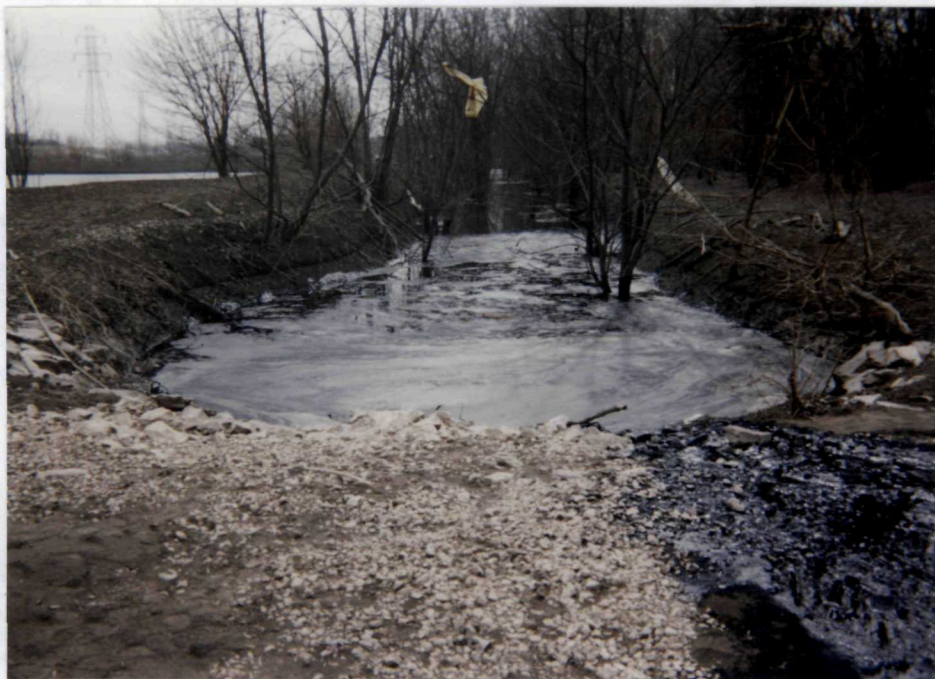
DESCRIPTION: North-South stretch of drainage ditch

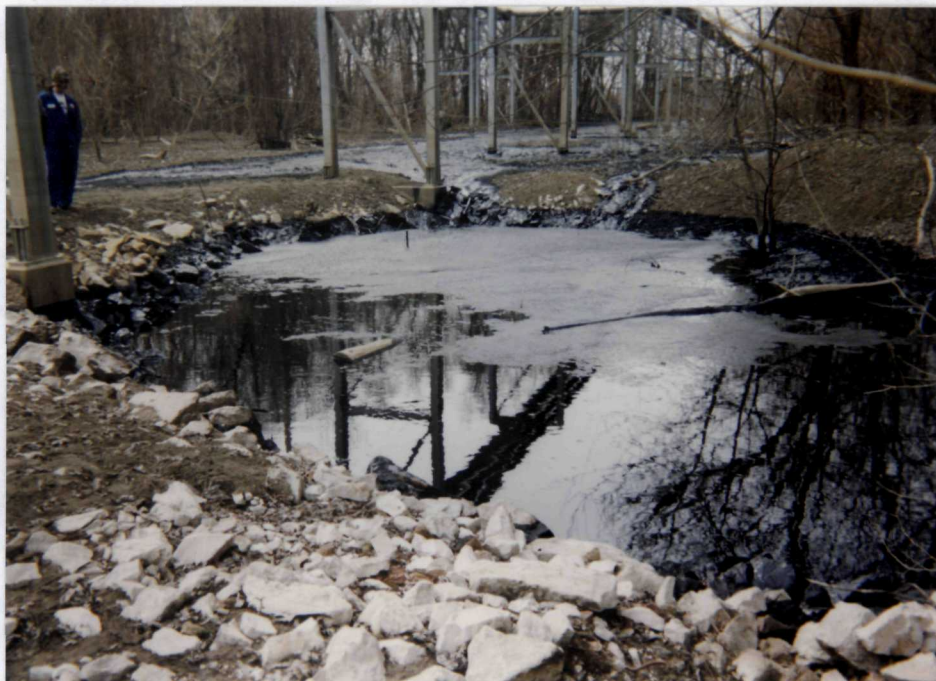
DESCRIPTION: Retention pond located north of north-south drainage ditch and north of pipeline.

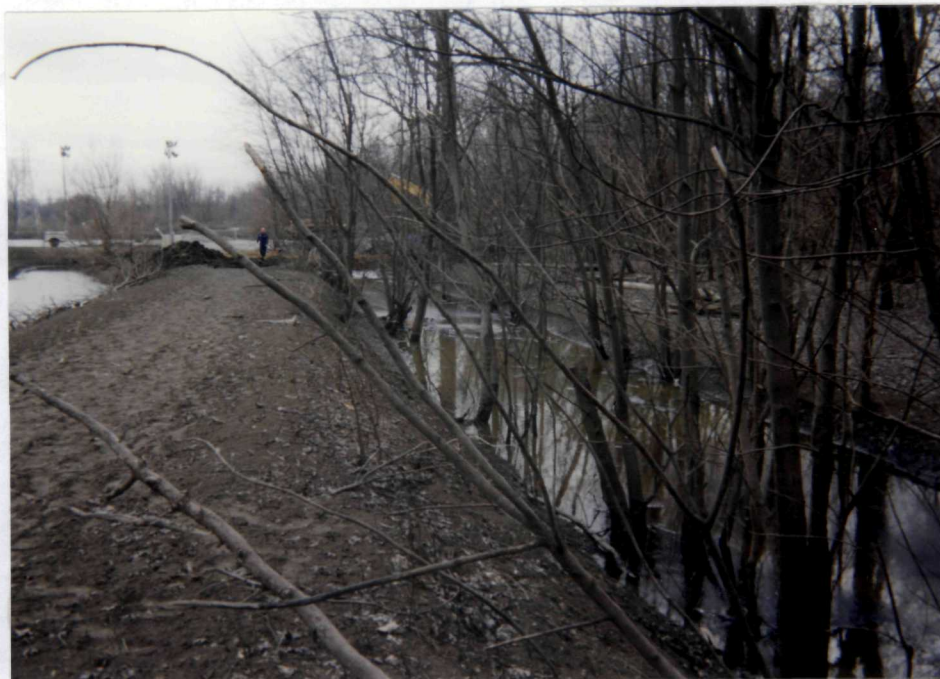
DESCRIPTION: North-south drainage ditch.

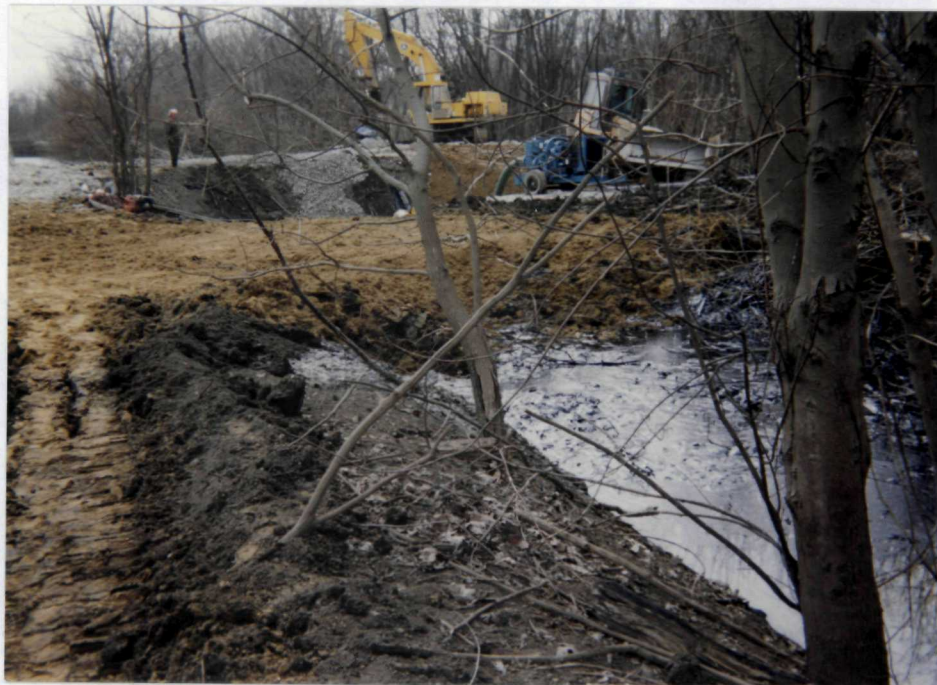
DESCRIPTION: Dam at south end of north-south drainage ditch.

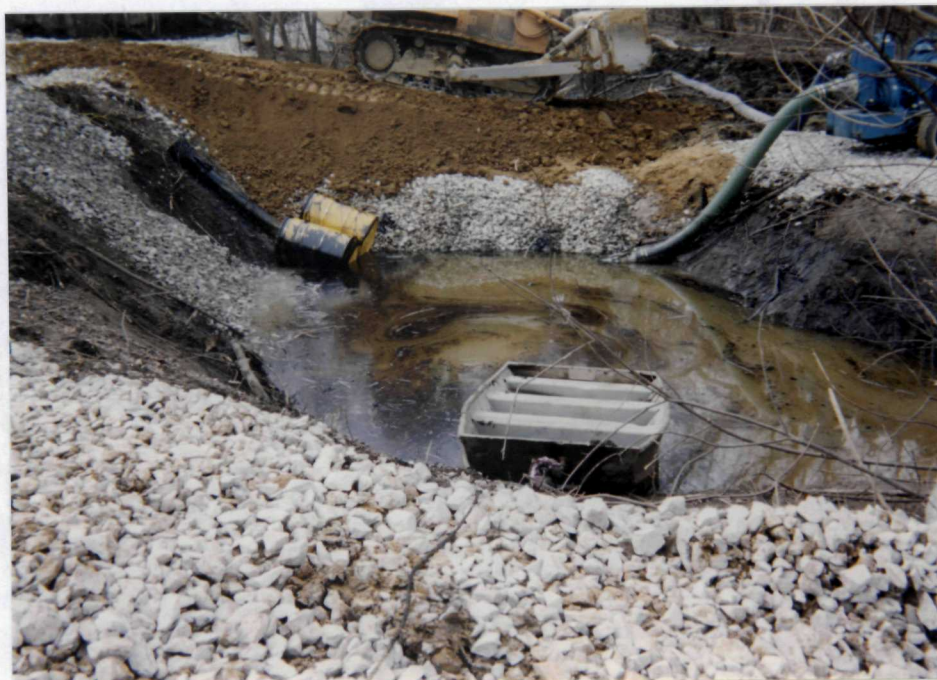
DESCRIPTION: Point where east-west and north-south ditches meet. A discharge pipe from holding ponds flows into here. Water is being pumped from below oil layer to east-west ditch where it will then flow to the Mississippi River.

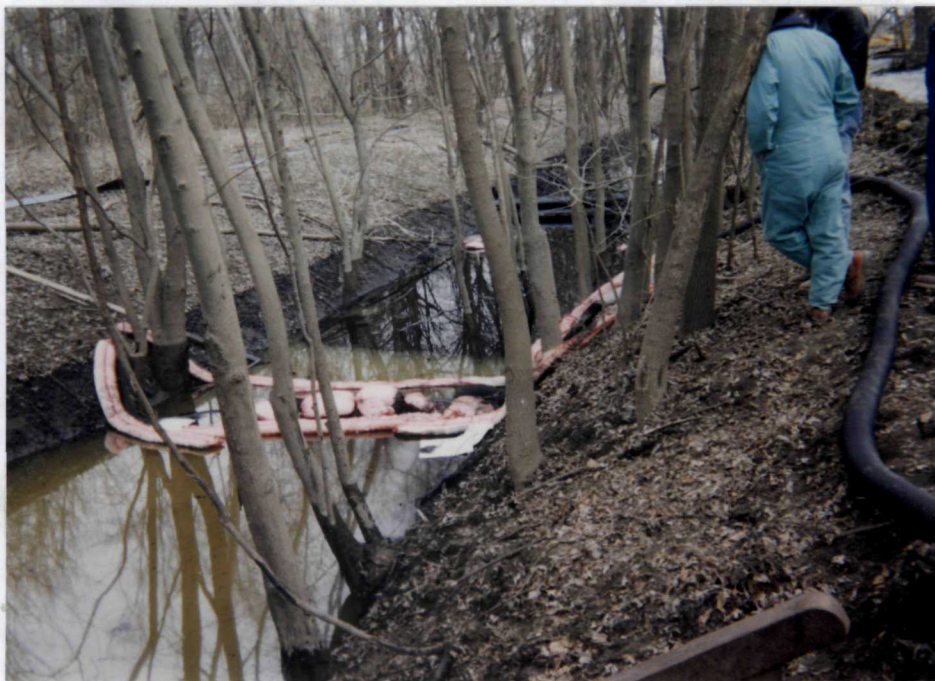
DESCRIPTION: East-west ditch being bermed in areas where there is oil accumulation.

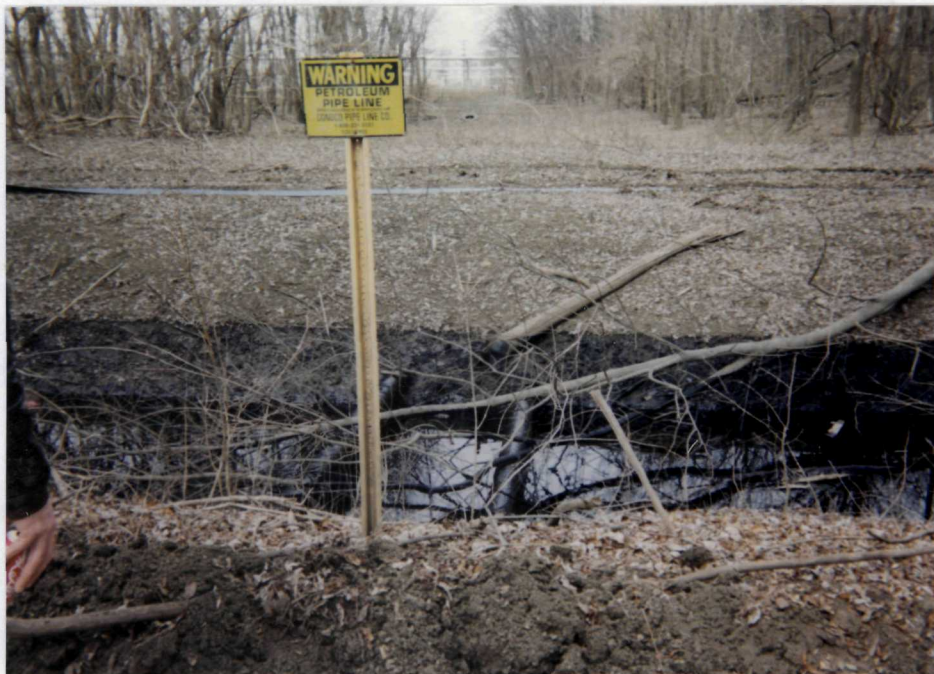
DESCRIPTION: Oil on east-west ditch.

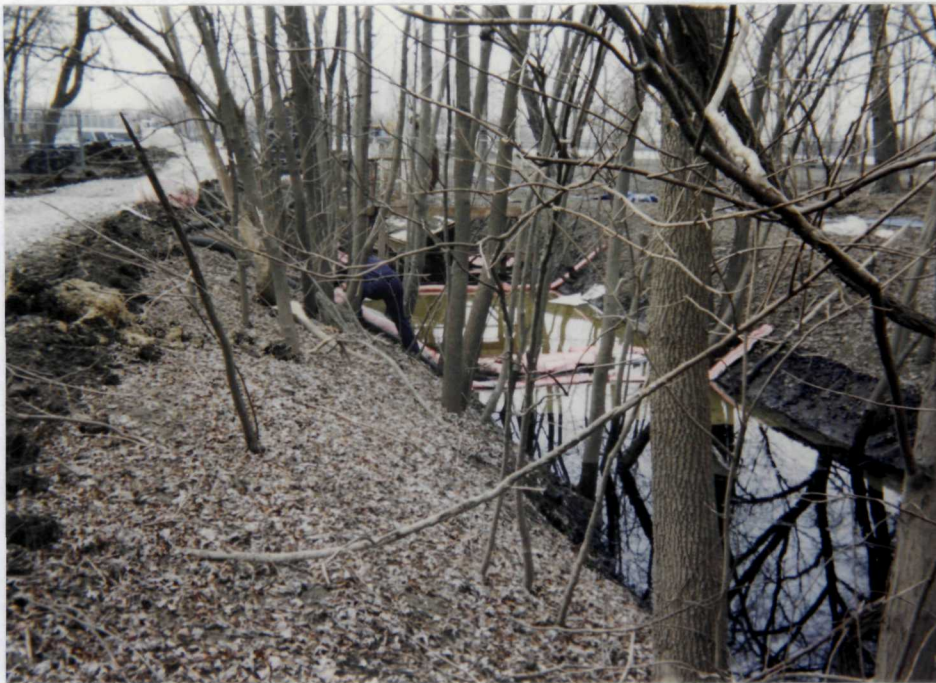
DESCRIPTION: East-west ditch.

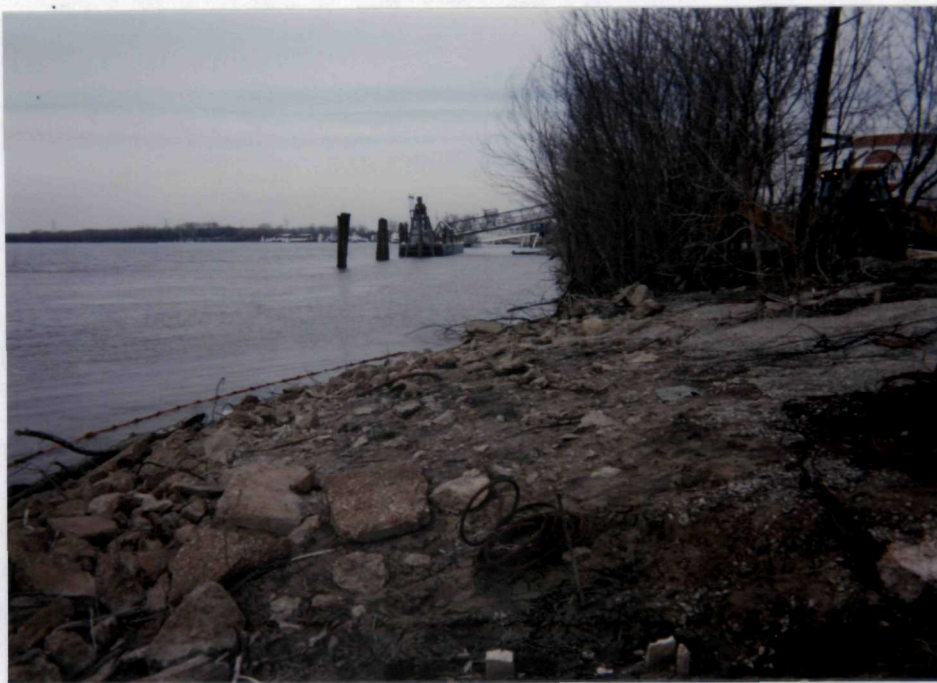
DESCRIPTION: Boom along the Mississippi River bank.

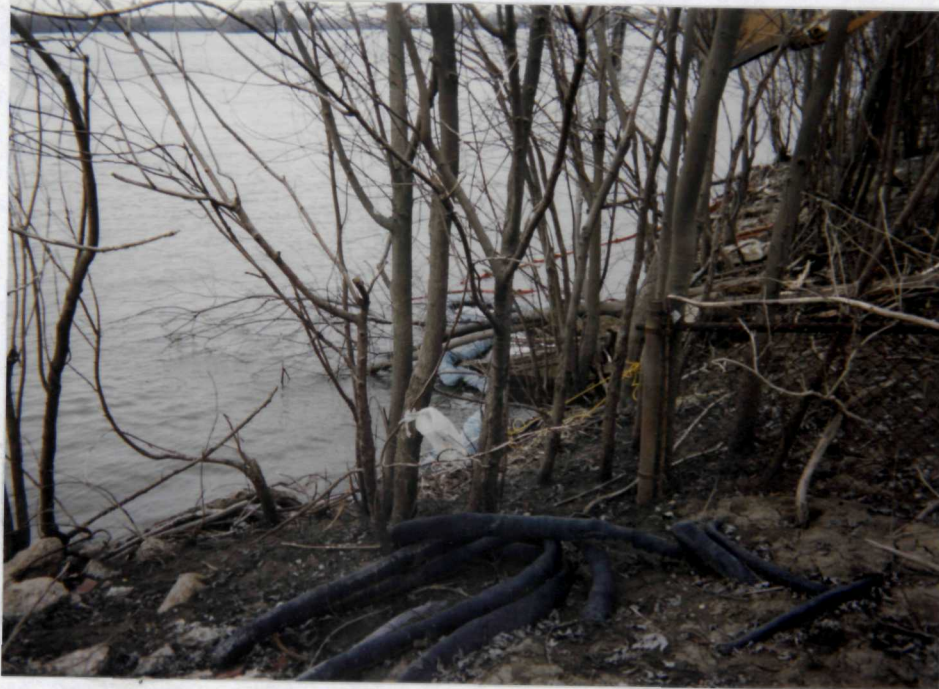
DESCRIPTION: Booms in place along the Mississippi River bank.

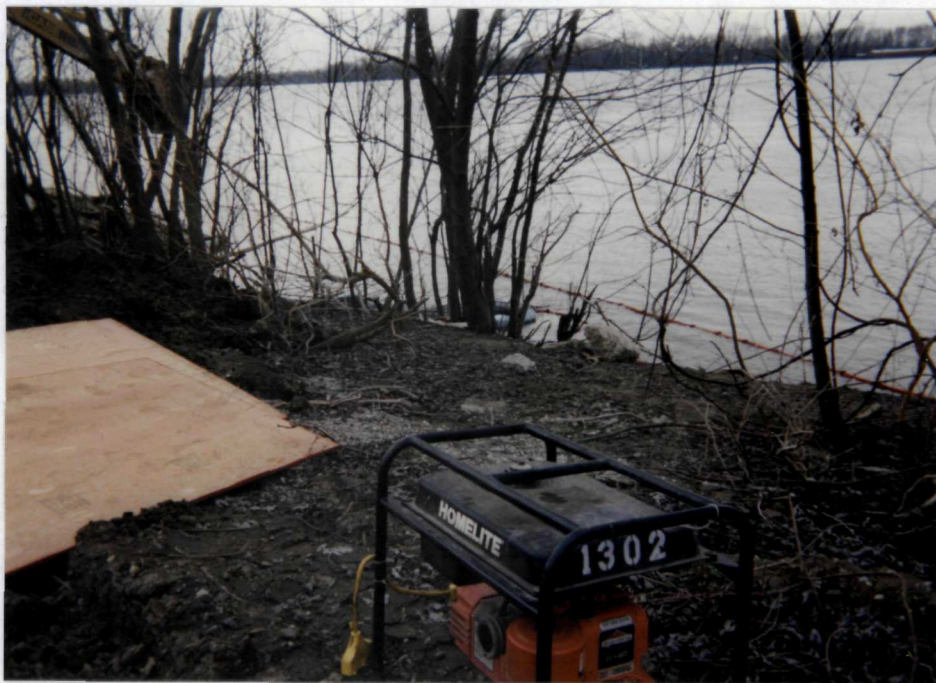
DESCRIPTION: Boom in place along the Mississippi River bank.
